Mason Main Street Facade Study

In this facade study Mason Main Street provides architectural consultation to building owners and merchants in the downtown area. The architect based his recommendations on the Secretary of the Interior's Standards for Rehabilitation. By observing historic photographs of each building he was able to create an accurate design of the original facade.

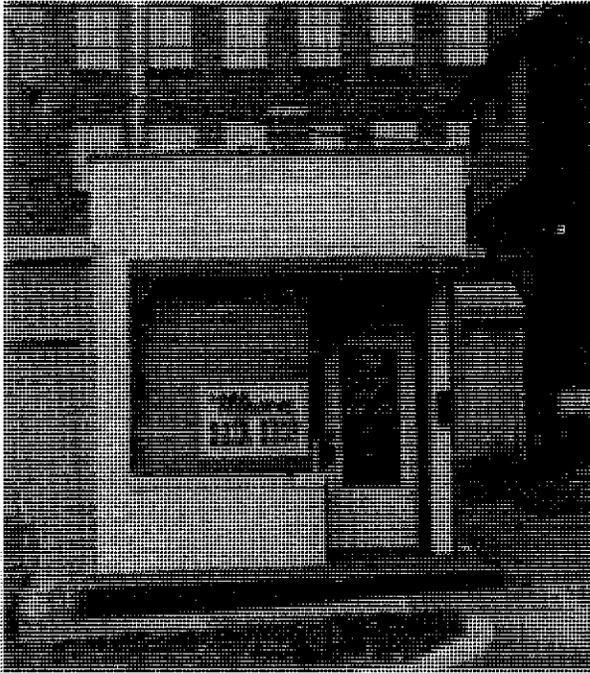
249 - 251 S. Jefferson Street

The wooden window sill adjacent to the main entrance is in very poor condition and should be replaced. The window jamb on the left side of the display window is also rotted and should be replaced. The cost of these replacements should be minimal. The display window is in need of caulking. The trim around the top of the window is also in need of minor repair.

The original red brick has been painted white to height of approximately seven feet above the sidewalk. The paint should be removed followed by restoration of the original red brick. If this is impossible, an alternative would be to paint the entire front of the building a red color similar to the red brick that is found on the upper portion of the building.

The windows appear to be original and are in good condition, even though they are single pane glass. No changes are necessary to the windows. The spandrel glass above the door and the windows is original. Two pieces of the ribbed spandrel glass have been broken. The ribbed glass could be replaced with similar material that would be available today. The no longer used 1x3 wooden board above the transom glass and the band of caulking above that should be removed.

Strip paint from lower portion of building. Repair and restore masonry to its original color texture.

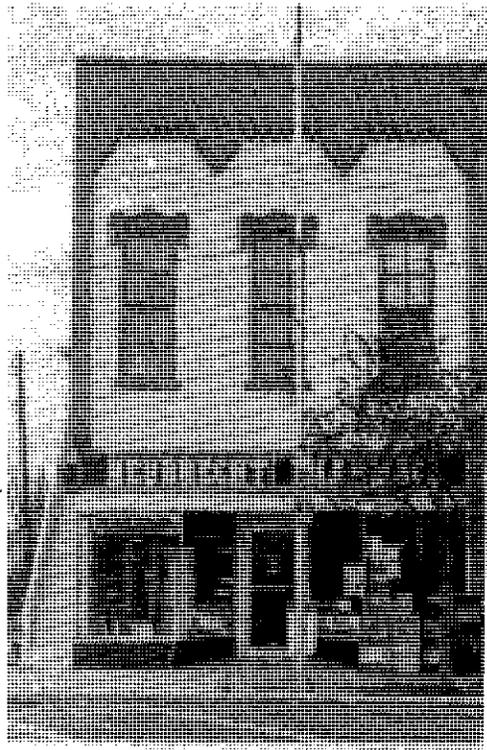
NEUBRECHT PHARMACY
103 East Maple Street
1883

The parapet wall along the roofline on the west side of the building is in poor condition. It would behoove the owner of the building to make repairs to this masonry before it totally deteriorates. We would further recommend that a proper cap be placed on top of the parapet wall to prevent moisture from infiltrating the top of the wall. This would help to prevent further deterioration of the masonry.

The transom windows above the main entrance have been removed and replaced with vertically scored plywood. This is not historically accurate, however, on an interim basis it could remain. The backlit sign in the transom should be removed and replaced with a surface mounted, single sided, sign of historic character and scale. Raised letters and mouldings on the sign board will help to create the appropriate historic image. Modern plastic letters should not be used. A properly designed sign board could fit nicely over the spandrel area and would not be terribly expensive.

The store front is not original nor is it historically correct. The aluminum frame system for the display windows is in poor condition. As a minimum this should be repaired and painted in with the color scheme of the building, either in cream color or preferably a dark green. The aluminum entrance door could also be painted in with the color scheme.

There is a broken ceramic tile at the right side of the entrance opening. If the owner has any extra tile, this should be replaced. If there are no remaining extra tile, we believed that this could be patched in with the cement plaster or epoxy and painted to blend with the surrounding areas.

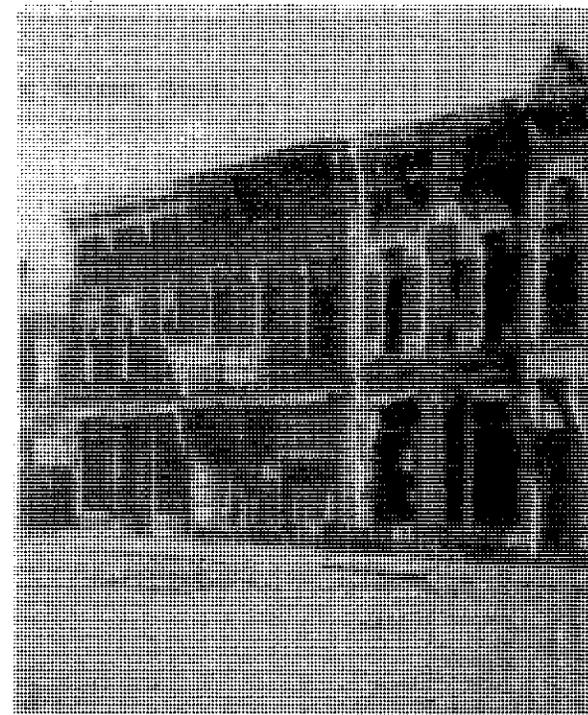
DR. GLEN A. LINSLEY
109 East Maple Street
1883

This building has not been as well maintained as the Neubrecht Pharmacy. The building still retains the basic Italianate character with the corbeled brick pattern in an inverted pyramid above the second story windows. Original double hung 4 over 4 windows have been removed and replaced with smaller double hung windows with cedar shingles closing the upper portion of the window openings. Original ornately carved stone lintels still remain.

A copper mansard fascio has been installed just below the second story window sills and the entire commercial storefront below that point has been removed and replaced with more contemporary appearance. Two doors on the front of the building are of crossback design more closely meeting a colonial style. A secondary mansard roof has been installed over the doors and windows as a protection. This mansard is constructed of wood with cedar shingles.

The double hung windows on the upper level are not the original windows. The height has been cut down by approximately one-third. The windows should be replaced with double hung windows duplicating the four over four windows found in the Neubrecht Pharmacy building. Windows and frames should be painted a historic color to complement the color scheme used in painting the brick.

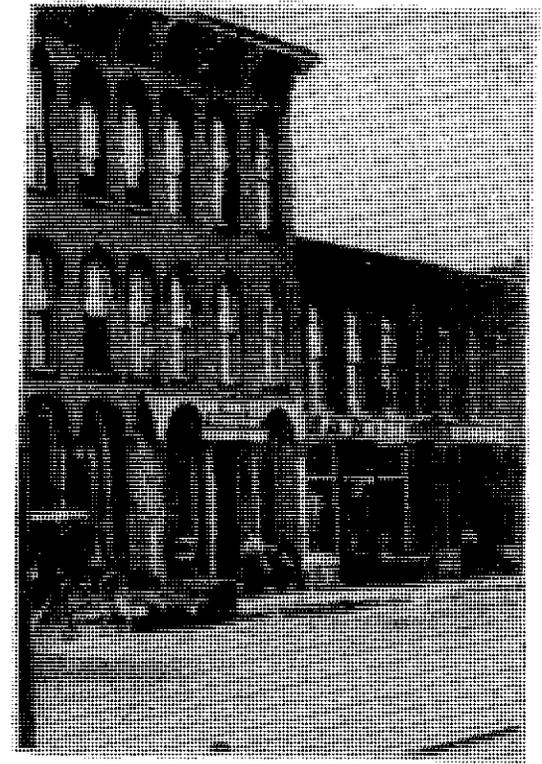
THE SHOPPING GUIDE
140 -144 East Ash Street
1879

ARCHITECTURAL DESCRIPTION: The Shopping Guide is a three story commercial building with very little of the original architectural character remaining. The upper two stories are faced with brick which is capped with a metal coping. There are seven window openings on the second story all of which appear to have been altered in height. The sash presently occupying these openings is of aluminum construction which post dates the period of the building. The third story has two remaining openings have also been scaled down in height and glazed with aluminum sash. The brick has been painted red.

The upper two floors of the building are brick, however, the window openings have to be altered. The brick has been painted a reddish color which is historically appropriate. The upper six feet of the brick wall is in bad condition. We would recommend repair of the masonry and repainting the brick. The cop on top of the brick wall should be repaired so as to prevent infiltration of moisture.

Appropriate historically designed signage in the form of a surface mounted sign with raised letters and mouldings would also enhance the building.

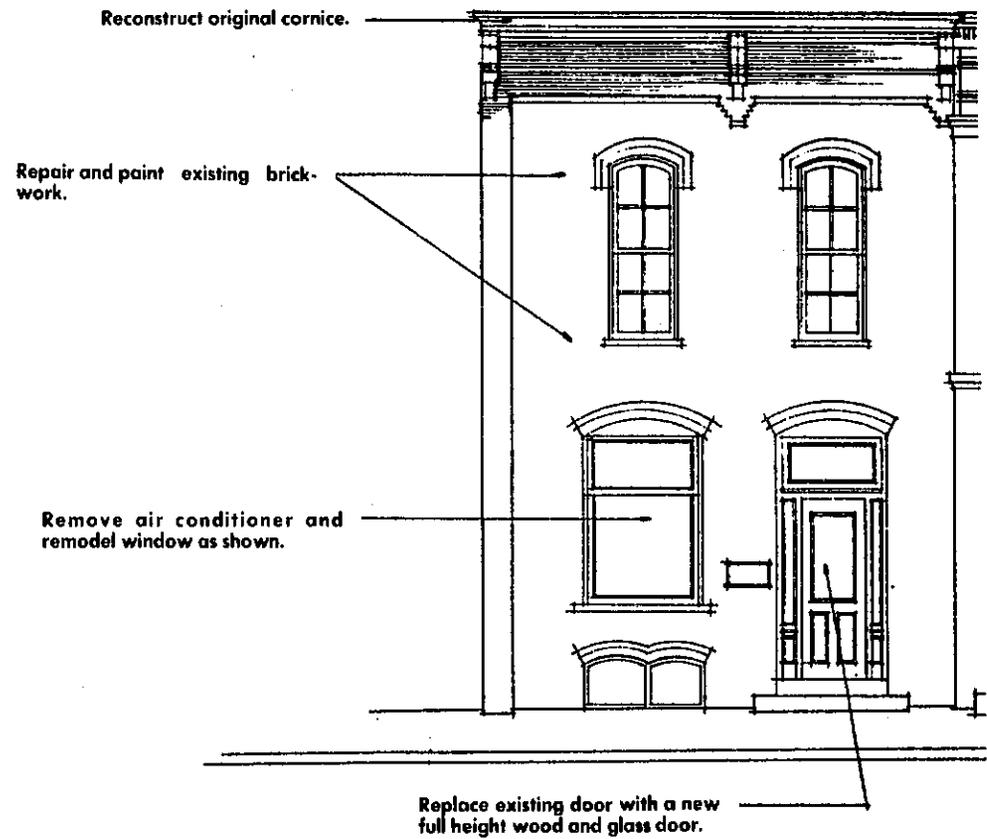
ALDRICH FLORAL STUDIO
440 S. Jefferson
1879

An entryway on the right hand side of the building serves the main level and is set in an elliptical shoped brick archway. The original wooden entrance has been replaced with an aluminum entrance, sidelite and transom. The elliptical portion of the transom has been closed with an opaque material.

Three round topped, 4 over 4 windows are set in recessed brick panels at the second story. The windows are capped with brick arched lintels with stone keys. The windows are original, however, they appear to be in poor condition.

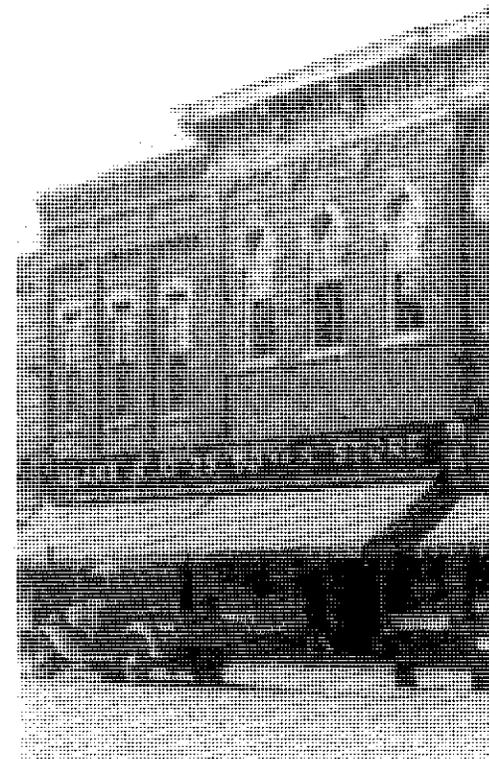
KEAN'S
412 S. Jefferson Street
1887

QUICK FIX: The southerly bay of the Kean block is most nearly representative of the original building. The wood frame display window on this end of the building are original and in keeping with the turn of the century architecture. The next two bays have been remodeled using wider brick piers with brick panels below aluminum display windows creating an arched appearance. The southerly 75 feet of this building is in nearly original condition at the second story level.

The three foot high metal sign with plastic letters should be removed and replaced with a sign that is more historic in character. This would be a wooden sign with some applied moldings and applied letters painted with historically appropriate colors selected from the color palette available at the Mason Main Street office.
