Mason Main Street Facade Study

In this facade study Mason Main Street provides architectural consultation to building owners and merchants in the downtown area. The architect based his recommendations on the Secretary of the Interior's Standards for Rehabilitation. By observing historic photographs of each building he was able to create an accurate design of the original facade.

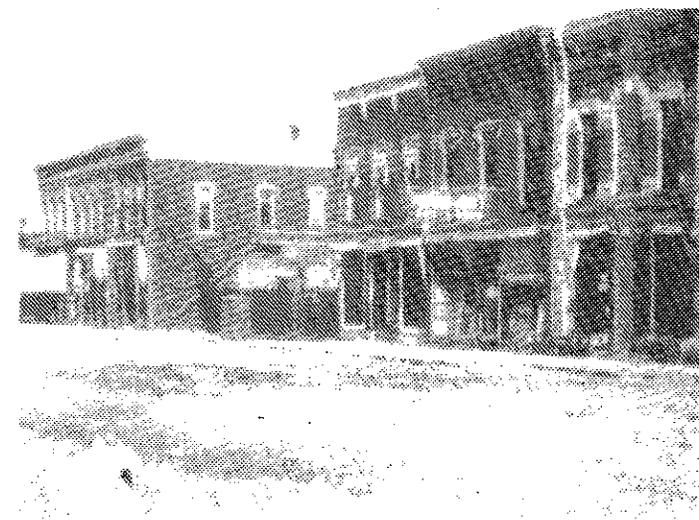
NEUBRECHT PHARMACY
103 East Maple Street
1883

The parapet wall along the roofline on the west side of the building is in poor condition. It would behoove the owner of the building to make repairs to this masonry before it totally deteriorates. We would further recommend that a proper cap be placed on top of the parapet wall to prevent moisture from infiltrating the top of the wall. This would help to prevent further deterioration of the masonry.

The transom windows above the main entrance have been removed and replaced with vertically scored plywood. This is not historically accurate, however, on an interim basis it could remain. The backlit sign in the transom should be removed and replaced with a surface mounted, single sided, sign of historic character and scale. Raised letters and mouldings on the sign board will help to create the appropriate historic image. Modern plastic letters should not be used. A properly designed sign board could fit nicely over the spandrel area and would not be terribly expensive.

The store front is not original nor is it historically correct. The aluminum frame system for the display windows is in poor condition. As a minimum this should be repaired and painted in with the color scheme of the building, either in cream color or preferably a dark green. The aluminum entrance door could also be painted in with the color scheme.

There is a broken ceramic tile at the right side of the entrance opening. If the owner has any extra tile, this should be replaced. If there are no remaining extra tile, we believed that this could be patched in with the cement plaster or epoxy and painted to blend with the surrounding areas.

The color scheme used on the Neubrecht Pharmacy is partially correct. The cream color used on the majority of the brick wall is depictive of cream colored brick found quite frequently on the buildings of this vintage. The green color used on the brick pilasters is not correct. One could expect to find the pilasters to be a reddish brown brick which would blend with the color scheme or cream color to match the remainder of the building. The window caps and sills should be painted a buff/gray to depict the stone of which they are constructed.

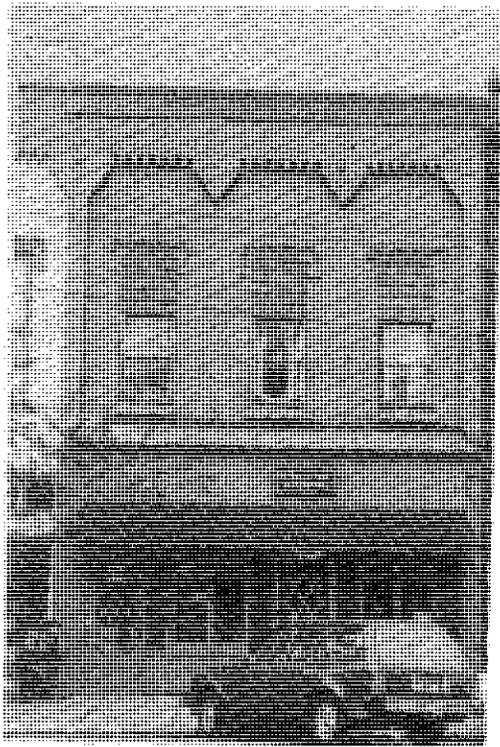
DR. GLEN A. LINSLEY
109 East Maple Street
1883

This building has not been as well maintained as the Neubrecht Pharmacy. The building still retains the basic Italianate character with the corbeled brick pattern in an inverted pyramid above the second story windows. Original double hung 4 over 4 windows have been removed and replaced with smaller double hung windows with cedar shingles closing the upper portion of the window openings. Original ornately carved stone lintels still remain.

A copper mansard fascio has been installed just below the second story window sills and the entire commercial storefront below that point has been removed and replaced with more contemporary appearance. Two doors on the front of the building are of crossback design more closely meeting a colonial style. A secondary mansard roof has been installed over the doors and windows as a protection. This mansard is constructed of wood with cedar shingles.

Two casement type wooden windows have replaced the original storefront display windows. Brick has been installed below the windows with a rowlock sill running the length of the building. Wooden louver shutters are placed on either side of the casement windows.

The double hung windows on the upper level are not the original windows. The height has been cut down by approximately one-third. The windows should be replaced with double hung windows duplicating the four over four windows found in the Neubrecht Pharmacy building. Windows and frames should be painted a historic color to complement the color scheme used in painting the brick.

The mansard roof and the crossback doors are inappropriate for the victorian style of architecture, however, it would seem ill-advised to do anything with these elements other than painting until such time as they could be removed and an appropriate historic storefront constructed. Shutters should be removed at this time as they are inappropriate to the architecture.

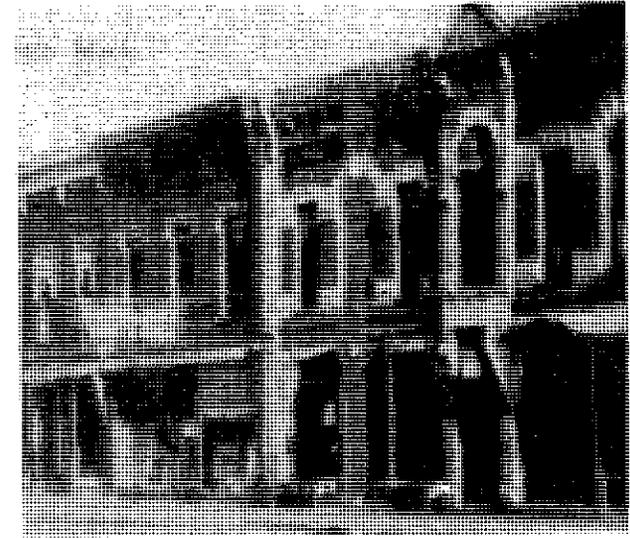
FIEDLER INSURANCE
117 - 119 East Maple Street
1889

QUICK FIX: These two stores occupy one building which maintains a great deal of its original architectural character. The second story is intact with the exception of the windows over the Fiedler Insurance Agency. The original double hung windows have been replaced with a jalousie type louver windows. These three window openings should be refitted with double hung wood windows matching the remaining original windows.

The masonry and cornice work appears to be in very good condition on this building. The gray paint should be chemically removed from the masonry so that the original beauty of the stone and brick masonry could be revealed. Sandblasting or other abrasive methods of removal must be avoided. If removal of the paint is impossible, we would recommend painting the brick portion of the building in a red color which was original as made apparent with the aging of the gray paint. The stone sills, belt courses and pilasters should be painted in a buff/gray stone color if the painting option is selected.

The storefronts at street level are not original. The brick knee walls below the display windows are of a hard-fire orange/brown brick. As a minimum, these should be painted the same color as the upper brick. For accurate restoration, which their building deserves, they should be removed and wooden panel type knee walls as shown on early photographs should be installed in their place. The aluminum storefront glazing system should be painted to tie in with the color scheme of the remainder of the building as a minimum and for accurate restoration should be replaced with wood window frames, door frames and doors.

The transom panels over the display windows have been covered with a striated plywood panel. The panels are installed in such a manner that we believe the original transom panels are still behind the plywood. If this is the case, the plywood should be removed and the transoms restored for a very nominal amount of money. If the transom glass is not found in removing the plywood, the original transom panels should be reconstructed to match the detail shown on early photographs.

The sign boards on both buildings are very acceptable and, if they are painted in with the historic color scheme of the building, they would read very nicely.

The aluminum storm windows on the stairway and on the Lilliput Shop should be painted to blend with the historic painting scheme on the remainder of the building unless the owner is willing to do away with the door which would be much more acceptable.

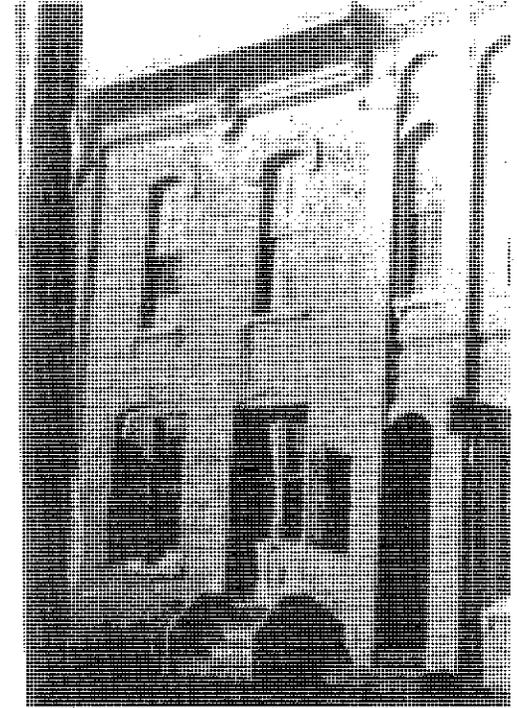
**THOMAS L. HOPP, DDS
BUILDING
448 S. Jefferson
1879**

ARCHITECTURAL DESCRIPTION: Dr. Hopp, dentist, occupies a two story brick masonry building of Italianate design. The design of the building is simple in character with a pilaster on both sides of the main facade turning into a corbeled brick panel above the second story windows. The corbeled panel creates a pyramid at the center of the building. An original cornice around the top of the flat roof building has been removed and the parapet wall has been extended with concrete block. The brick has been painted gray.

The street level facade is simple in nature with an entrance on one side and a window on the other side. The entrance has two steps rising from the public sidewalk to a doorway located in the center of semi-circular arched masonry opening. The original door remains in the opening, however, it has been covered on the outside by an aluminum storm door of approximately two feet less in height. Above the door is found a glass transom of a rectilinear shape.

The window to the left of the main entrance also has a semi-circular arched masonry opening. The wooden window has been altered to allow installation of a window air conditioning unit on the lower portion of the window. Below this window is found two basement windows with a compound semi-circular arched top.

The two second story windows are of double hung design with a 4 over 4 pattern. The windows are set in semi-circular round top openings with a projecting brick hood.

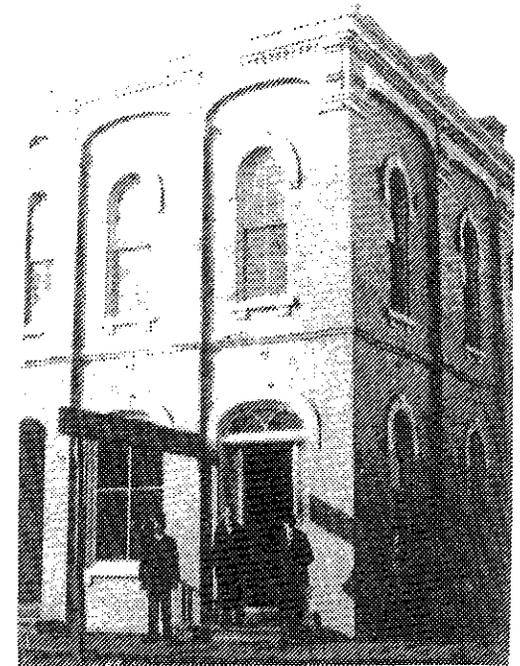
ALDRICH FLORAL STUDIO
440 S. Jefferson
1879

ARCHITECTURAL DESCRIPTION: The Aldrich Floral Studio is Romanesque Revival in design and is a highly ornamented two story brick masonry building. The street level facade of the building has two arched entryways. The smaller entryway on the left side of the building set back in a brick round topped arch leads to the second story of the building. This opening has been altered by replacing the original wood door with an aluminum storm door. The transom panel has also been increased in height to meet the shorter storm door. The glass in the transom panel has been painted over.

An entryway on the right hand side of the building serves the main level and is set in an elliptical shoped brick archway. The original wooden entrance has been replaced with an aluminum entrance, sidelite and transom. The elliptical portion of the transom has been closed with an opaque material.

Three round topped, 4 over 4 windows are set in recessed brick panels at the second story. The windows are capped with brick arched lintels with stone keys. The windows are original, however, they appear to be in poor condition.

The recessed brick panels of the second floor are capped with elliptical brick arches. The arches terminate in corbeled brick column capitals on four piers which run the full height of the building. The building is capped by a highly detailed brick pattern consisting of corbeled bricks and bricks laid in a dentil pattern. The upper portion of the brick parapet is in very poor condition. All of the brick has been painted with the lower portion being painted darker than the upper portion.

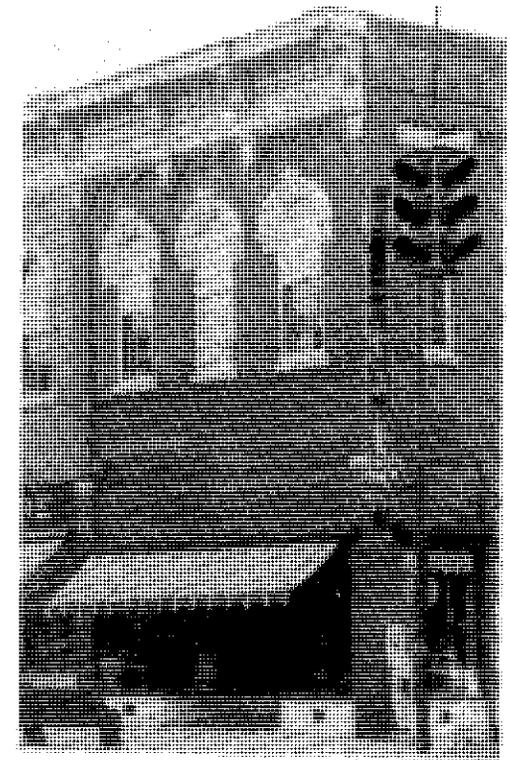
DAVIS MENS WEAR
400 S. Jefferson Street
1880

ARCHITECTURAL DESCRIPTION: The Davis Mens Wear building is a two story masonry building with very little of the original architectural character remaining on the front facade. There is only a hint of original Italianate design in the carved stone window hoods at the round topped window openings on the second story. The remainder of the architectural detailing has either been removed or covered over through remodelings over the years.

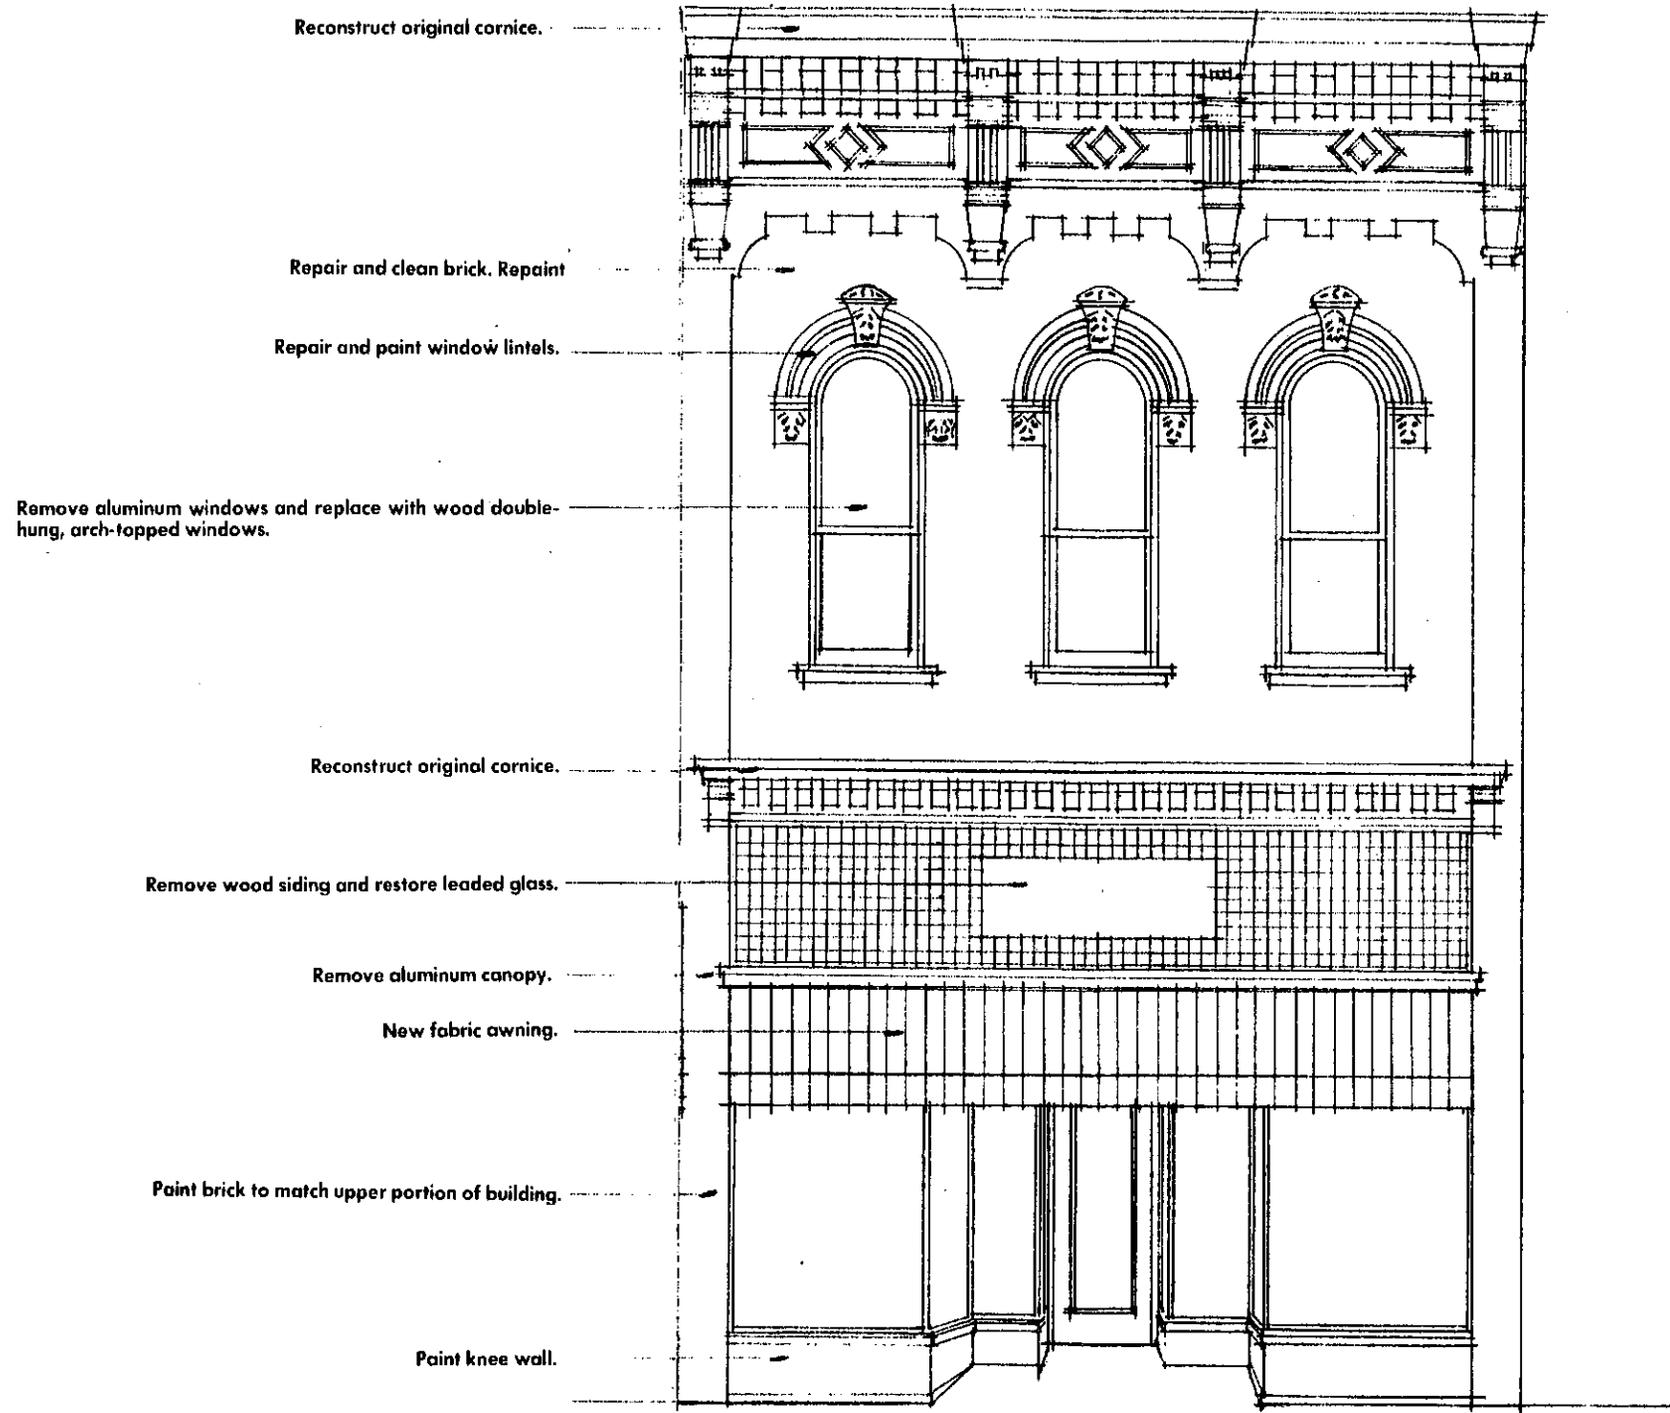
The second story windows which were originally 4 over 4 double hung wood windows with round topped upper sash have been replaced with smaller double hung aluminum windows. The arched portion of the opening has been closed with plywood panel. The arched openings are capped with ornately carved stone window hoods.

The main cornice on the top of the building which shows on the original photographs has been removed. The parapet wall at this location has been replaced by two courses of concrete block which is capped with concrete coping. The masonry in the upper portion of the building is in very poor condition. All of the brick on the upper portion of the building has been painted and is in the need of tuck-pointing and repainting.

QUICK FIX: This building originally had a wooden cornice on both Jefferson and Ash Street. The cornice has been removed and on Jefferson Street the two rows of concrete block have been constructed above the brick and this has been capped with a concrete parapet cap. The brick has been painted and the round top doublehung windows have been replaced with square top doublehung windows. The original brick openings remain in tact. An intermediate cornice below the second story windows has been removed and the leaded glass transom panel below that has either been covered over or removed and the opening closed with vertical tongue and groove boards.

For a "quick fix", the upper level of this building should be cleaned with medium pressure water or hand brushed to remove all loose paint scale followed by repainting. The paint color should be reddish brown in color, more closely matching the original brick color. The square top doublehung windows should be replaced with round top doublehung windows matching the original windows that are shown on early photographs. The stone window hoods above the round top windows should be painted a buff/gray more closely depicting the original stone material. The windows should be painted a color to complement the brickwork. In this case, we would recommend a dark brown as it would also complement the color of the display window framing on the lower level.

The street level store front is not original, however, the replacement dates back approximately to the 1930's or 1940's. The storefront should be retained. The display windows are framed with bronze framing material with a dark patina. This patina should be preserved. The entrance door has been replaced with a natural aluminum and glass door. We would strongly suggest that the aluminum entrance be coated with a bonding elastomer and painted to match the bronze framing system. The soffit at the entry way is constructed of wood panels painted white with natural wood batten strips. The batten strips and the cornice at the top of the display windows should be cleaned and refinished. The panels between the batten strips should be repainted also.

With the removal of the aluminum canopy on Jefferson Street, we would recommend that the facade be fitted with a fabric awning.

Much of the same comments apply to the north side of the building. The brick should be painted the same as the front, the original round top double hung windows should be restored on the second story and also on one window on the first story toward the back of the building. The stairway enclosure going to the second story should be painted a historically accurate color with the possibility of accentuating the metal brackets supporting the stairway.

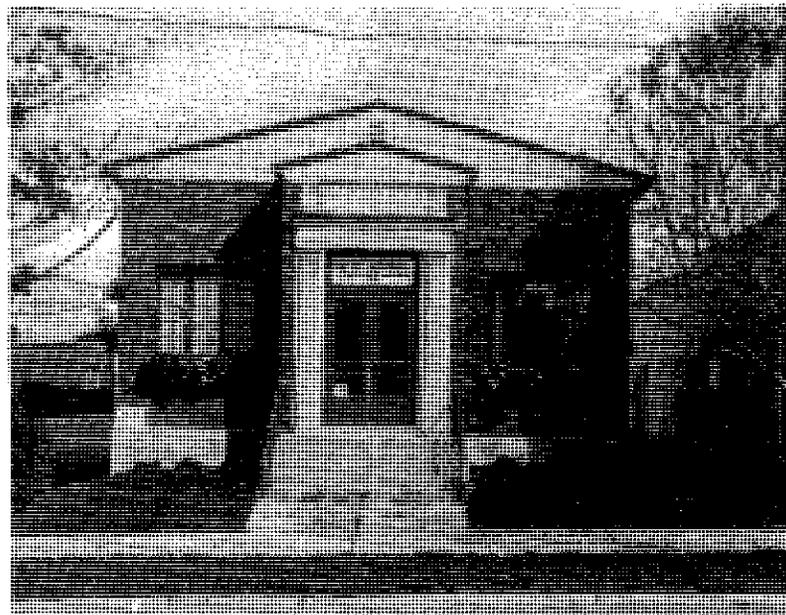
STID BROWER INSURANCE
138 West Ash Street
1937

ARCHITECTURAL DESCRIPTION: The Brower Insurance building is a simple one story brownish-red brick building constructed in 1936 in the Federal style. The building has a main entrance centered on the south facade and projecting approximately 4 feet in front of the main wall. The main floor is raised approximately 2 feet above grade. Nicely detailed with flat faced fluted stone columns capped by a stone pediment, the main entrance to this building is the most important architectural element.

Wooden three-panel casement windows with internal muntin bars are found on either side of the main entrance. These windows appear to be replacement sash for what was probably originally a steel sash. Surface mounted wooden planter boxes are found below the sill of each window.

In the case of this building, the sloped roof should either be done appropriately for the style of architecture or it should be removed and the flat roof originally found on the building restored.

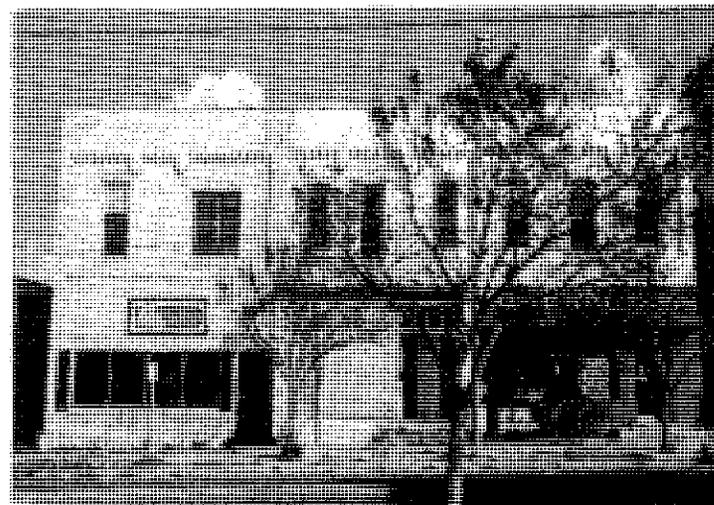
FEINTUCH BUILDING 124 - 136 West Ash Street

The easterly bay has been changed recently by fire and has sustained moderate damage on the interior and the exterior. As a result of the fire, the easterly and central bays have been boarded up.

The central bay, while covered up with plywood, appears to be in near original condition. The original wood and glass doors to the storefront to the stairway to the second floor are still in place. An intermediate cornice is still in place, however, it is in need of repair.

Narrow louver style window shutters are found on either side of the window and are not in keeping with the character of the building. A contemporary sign located on the brick above the horizontal band of windows is also out of keeping with the architectural character of the building.

The second story of all three bays of the building remains basically in original character. The easterly and central bays have three sets of double hung windows which are divided into 3 over 3 lites with horizontal muntin bars. We question whether the horizontal muntin bars are original.

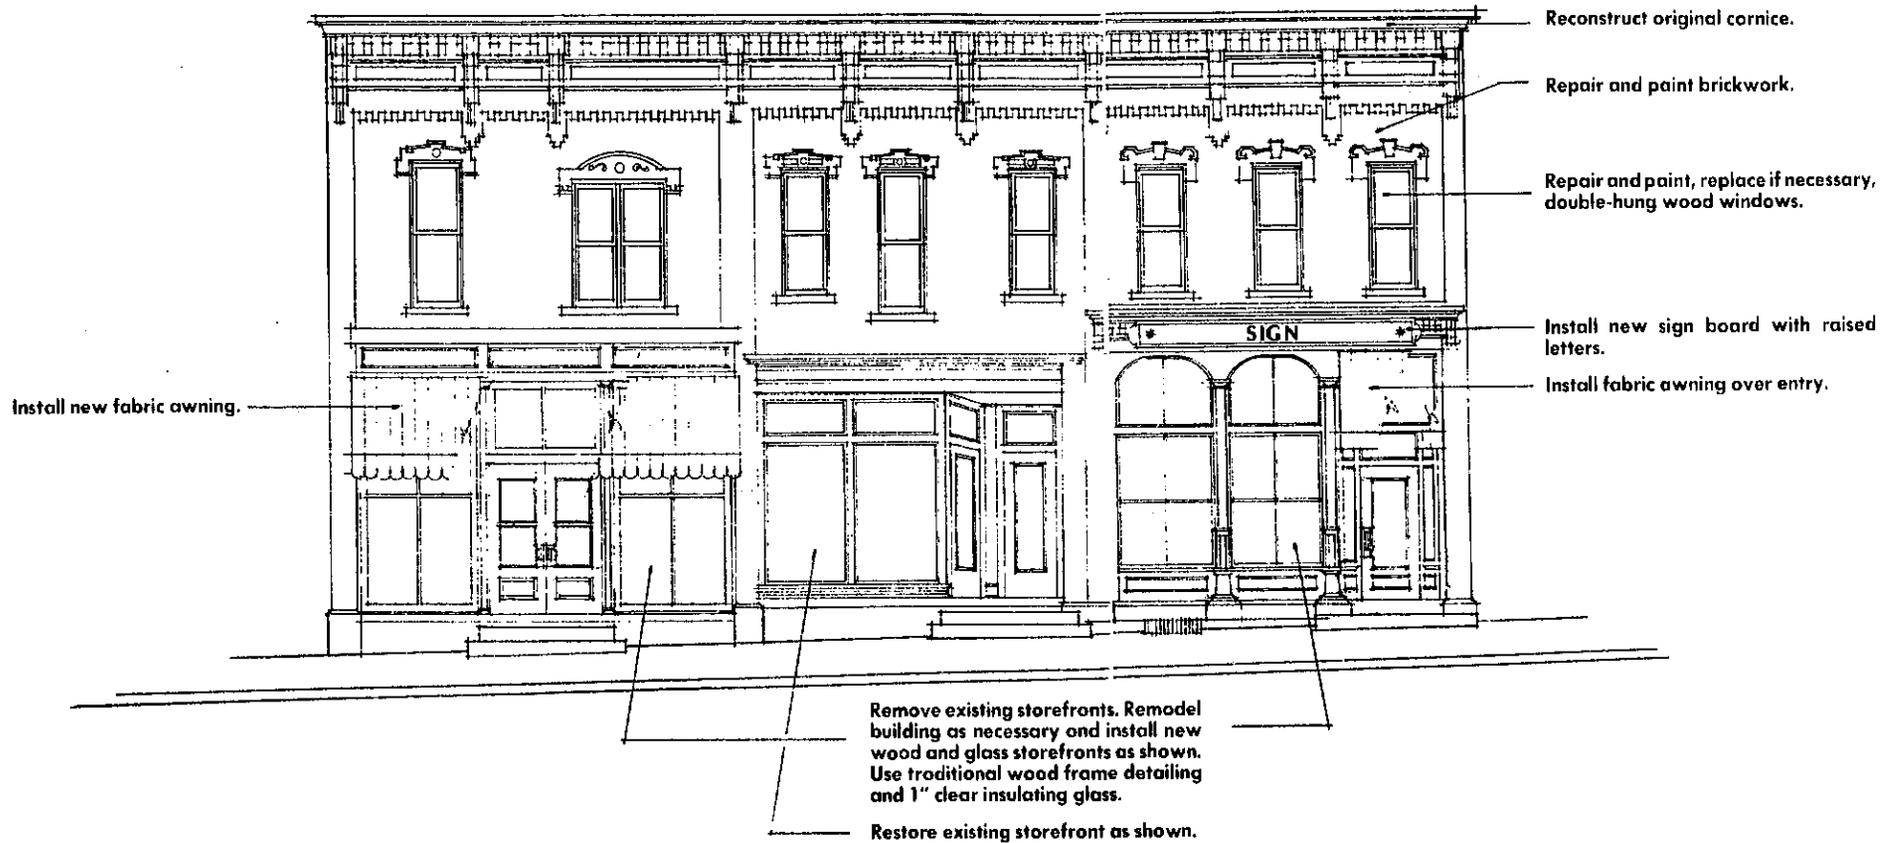
FEINTUCH BUILDING Continued

ARCHITECTURAL DESCRIPTION: The lintels over the windows on the easterly bay are slightly different than those found on the central bay supporting our theory that the building was built in phases.

The brick on the street level and on the second story level of the building has been painted and is in a deteriorated condition.

QUICK FIX: Since the new owners will be restoring the original storefronts on the center and east end of the building, the "quick fix" recommendation will address primarily the Penny Whistle Hair Shop. This portion of the building was the most recently constructed of the three bays. The building originally was constructed in three separate bays as in evidenced by the different window hoods on each of three buildings. The street level storefront has been greatly altered in that the height of the window and door entrance has been lowered approximately 16 inches and new windows installed in a smaller opening. The bronze tinted windows are set in aluminum frames. Since bronze tinted glass is not historically correct, it should be replaced with clear glass and the aluminum frames should be painted to reduce their brilliant aluminum color. The shutters should be removed from the front of the building as they are totally inappropriate. The brick masonry should be painted a historically accurate color depicting of the brick used in the original building. We would recommend a reddish brown color.

Complete restoration of the storefront facade of the west bay of this building would involve significant change and is somewhat costly. The facade study for this building will illustrate how that building should best be restored totally to its original character.

The second story windows on all three bays of the building appear to be replacement sash. The windows are, for the most part, double hung windows with two horizontal muntin bars in the upper and in the lower sash creating three over three double hung sash. The horizontal appearance of these windows does not appear to be true character with the original building. We feel that these windows were originally one over one double hung sash. That original character should be recaptured by removing the muntin bars and rehabilitating the existing double hung windows. The remaining portion of the building, the center section, and the east section should also have the masonry painted more in keeping with the original architectural coloring of the brick. Window trim and storefronts should be carefully detailed and painted with historically accurate colors complementing the color of the brick.

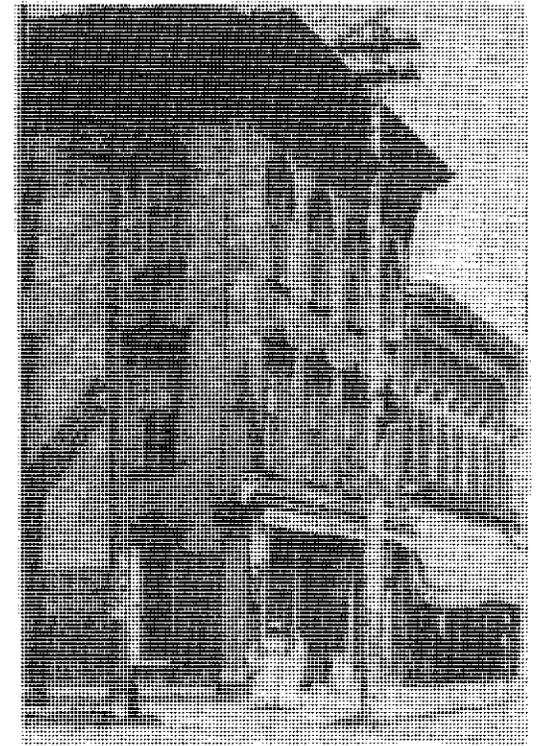
KENT SHOP
366 - 368 S. Jefferson
1879

ARCHITECTURAL DESCRIPTION: The Kent Shop is a three story building that has been greatly altered in recent remodelings. The third story has been covered with imitation cedar shakes constructed of aluminum. The second story has been totally covered with wooden siding with a board and batten pattern. Double hung, 2 over 2 windows with vertical muntin bars remain on the second floor.

The street level facade reveals signs of an earlier classical design with an intermediate cornice with large wooden dentils. The entrance is flanked on either side by flat faced fluted Corinthian columns. Beside each column is found a narrow window with a transom. The original entrance has been replaced with an aluminum storefront with tinted glass.

The brickwork on the street level appears to be replacement brickwork. The display window is framed in aluminum with large panes of clear glass. Above the display window is found five wooden framed transom lites, which appear to be part of the original classical design.

A beautiful sign board which is very much in keeping with the late 1800's architecture found within the district is located between the transom windows and the intermediate cornice. This sign appears to be the strongest architectural element remaining on the building.

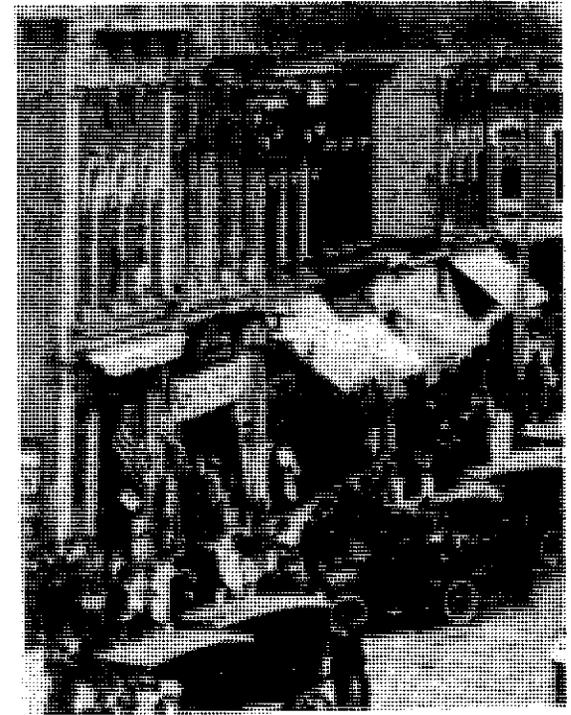
J & C WHOLESALE
330 S. Jefferson
1881

This building, which is part of the Mason State Bank complex, is a two story masonry building which has been "modernized" by applying porcelain enamel panels on the upper level. The original windows on the second story have also been removed and replaced with a steel sash of the 1940's vintage.

The street level storefront was renovated in approximately the 1930's as determined by the detail. The display windows step back to a centrally located aluminum entrance. Below the display window is found a black glazed ceramic tile. The outermost step in the storefront is a 90° angle with a stepback of approximately 16 inches. A curved glass and tile wall steps back a second time to meet the entrance at the center of the building.

The original photographs of this building indicate that it was a highly detailed building of Italianate design. It is uncertain if any of those architectural characteristics are still to be found behind the porcelain enamel panels.

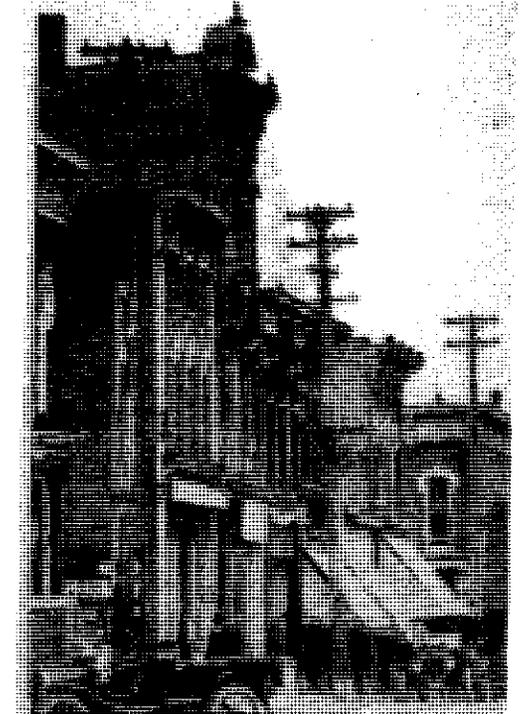
MASON STATE BANK
322 South Jefferson
1879 - 1880

The third story windows on the southerlymost portion of the building have been covered over entirely with porcelain enamel panels. The second story windows have been replaced with steel sash of a shorter height than the original double hung windows. The southerly portion of the building has a single door aluminum entrance on the south corner which leads to a stairway to the second floor. This entryway has a fabric awning over the transom. Approximately two-thirds of this portion of the building at the street level consists of narrow panes of glass set in aluminum frames. These frames run from the marble base to a lighter color porcelain enamel panel at the second floor level.

The center bay of the bank building now serves as the main entrance to the bank. A pair of aluminum and glass doors with an aluminum enameled glass transom located at the north side of the center bay serves as the entrance to the bank. A storefront of aluminum and glass three panels in width is found to the left of the entrance doors. Immediately to the left of the storefront windows is a night depository.

An intermediate canopy constructed of aluminum is located just above the display windows and entryway. This canopy covers the full width of the center portion of the building. Above the entryway canopy and just below the sills of the windows on the second floor is found a triangular shape projecting marquee which has a changeable temperature and time sign on two faces. A plastic faced backlit business sign with Mason State Bank name and logo is mounted above the second story windows in the center of the building.

The northerlymost bay of the Mason State Bank building is a duplication of the southerlymost bay with narrow vertical lites of glass set in aluminum frames running from the marble base to the light porcelain enamel panel at the second floor level. Second story windows are again reduced in height and replaced with steel sash.

The building is an example of 1950's or 60's "modernization" which has on the street level totally destroyed the original architectural character. It is doubtful whether any of the original architectural character such as ornate window hoods and lintels still remain on the second and third story portions of the building. For certain, a split pediment and ornate finials have been removed from the three story portion of the building. Main roofline cornices have also been removed from the entire building.

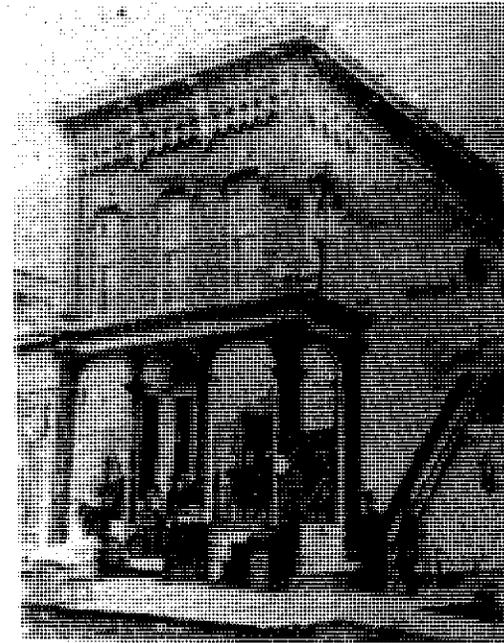
WARE'S PHARMACY
304 S. Jefferson
1880 - 1883

A corrugated metal panel runs the full width of the building between the canopy and what was originally the head of the transoms on the two story portion of the building. The second story portion of the northerly half of the building is in excellent condition. Three 4 over 4 double hung windows are set in a recessed brick panel. These windows have beautifully detailed carved stone window hoods. A brick pattern of corbeled brick with an inverted pyramid pattern is located just above the second story windows. An additional design of recessed crosses is found above the inverted pyramids. The brickwork is all painted a light blue color as the window hoods and window sills.

The original main cornice at the top of the building has been removed and is replaced by a flat white fascia which is not in keeping with the beautiful detailing found on the remaining upper portions of the building.

The windows on the upper level are original four over four doublehung accentuated by projecting stone or cast window hood. The detailing is very fine. These appear to be in excellent condition. The powder blue color selected for painting the masonry is totally inappropriate. The masonry should be repainted in a color that was more depictive of the masonry that was available at the turn of the century, i.e. reddish brown. The street level storefronts are totally reconstructed with split face concrete brick being used below the display windows, vertical prefinished metal siding covers the brick piers on the sides of the building and the display windows are set in aluminum frames. Transom panels have been covered over with vertical aluminum siding and a canopy constructed of aluminum extends the full length of the building.

QUICK FIX: The original cornice work around the roofline of this building has been removed. A metal closure cap has been installed to cover the deteriorated masonry at that point. As an interim step, this closure cap could be turned into a simple cornice quite easily by applying some moldings. A series of simple horizontal moldings at the top of the cornice projecting out approximately 6 inches would suffice at the top. Approximately 4 inches up from the bottom of this metal panel a simple molding approximately 3 inches in height could be applied to finish off the bottom portion of the cornice. This would be an interim solution until such time as the original cornice could be duplicated.

The canopy and the vertical aluminum siding covering the transom should be removed. If the original transoms still exist, they could be restored very easily. If they are not found in removing the aluminum, a program of reconstruction of the transom panels or constructing an opaque transom panel that would nearly duplicate the original transom panels should be undertaken.

The street level storefront facade should be restored to its original character, however, on an interim basis we would recommend that the split faced concrete brick and the vertical siding used to cover the brick piers, be painted to blend with the brick above and that the aluminum window framing system and the aluminum doors be painted to match the trim colors used on the windows at the upper level.

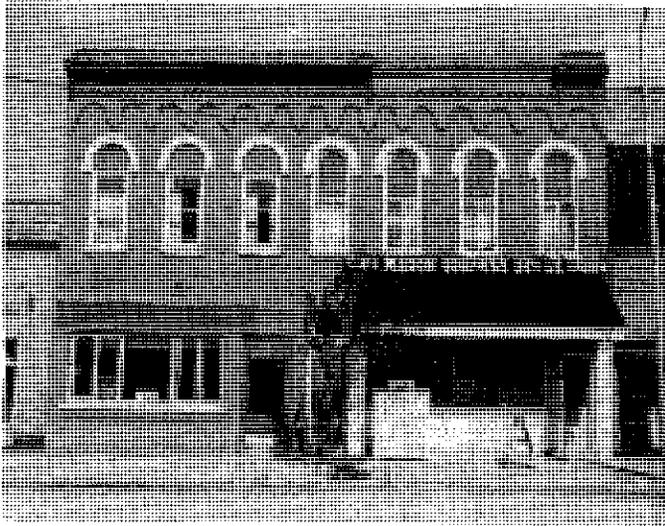
Decorative alarm tape pattern.

Replace existing aluminum storefront and door with full height insulating glass in wood frames and wood and glass entry door.

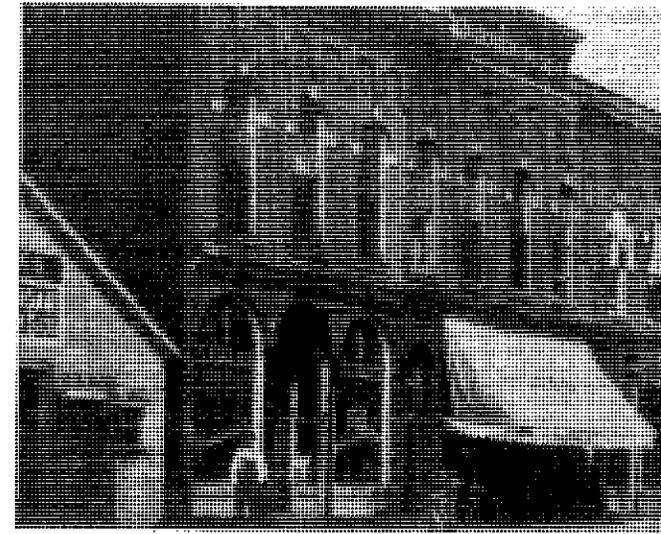
PADDOCK BUILDING
164 West Maple Street
1886

ARCHITECTURAL DESCRIPTION: The Paddock Building is a two story brick building of Italianate design. The basic architectural character still remains on the second floor and at the roof line, however, the street level facade has been greatly altered.

The storefront at the westerly portion of the building has been infilled with brick and wood. The display windows have been greatly reduced in size and have been replaced with fixed and casement windows which are totally out of character with the remaining portion of the building. A door recess is located on the east side of this bay.

A centrally located door at the stairway leading to the second floor has been reduced in width and replaced with a flush door with a diamond shaped vision panel. The door is shorter in height and is totally out of keeping with the architectural character of the building. A round topped transom above the door still remains, however, the glass has been painted over.

The easterly portion of the building has been remodeled in a completely different character from that found on the westerly portion of the building. This section of the building has been converted to a colonial look. The display windows consist of large lites of glass set in aluminum frames with imitation muntin bars located on the interior which created the appearance of 12 inch by 12 inch lites of glass.

The second story windows were originally 4 over 4 double hung windows with round tops. Three of the windows have been replaced completely with shorter double hung windows with the round top portion of the opening being closed with a plywood panel. The remaining four window openings have been altered by removing the lower sash and replacing that with a casement window. The upper round topped sash remains, however, the glass portion has been removed and a plywood panel has been installed in its place.

A portion of the original wood cornice at the top of the building still remains. Approximately 12 feet of the cornice is missing. The cornice consists of a simple flat cornice supported by small brackets. Three brackets of a larger size appear on the front of the building, however, these do not appear to be original brackets as they are of considerably larger size and the spacing has no relationship to the remaining detailing on the building. A short parapet wall exists above the cornice. A small section of remaining detail would indicate that this was capped with wood moulding and the entire parapet wall was capped with metal. Most of this original detail is missing and parapet is in very bad condition.

The brickwork on the second story portion of the building has been painted red while the brick at the westerly bay at the street level has been painted white. The round topped arches of brick over the second story windows have been painted white.

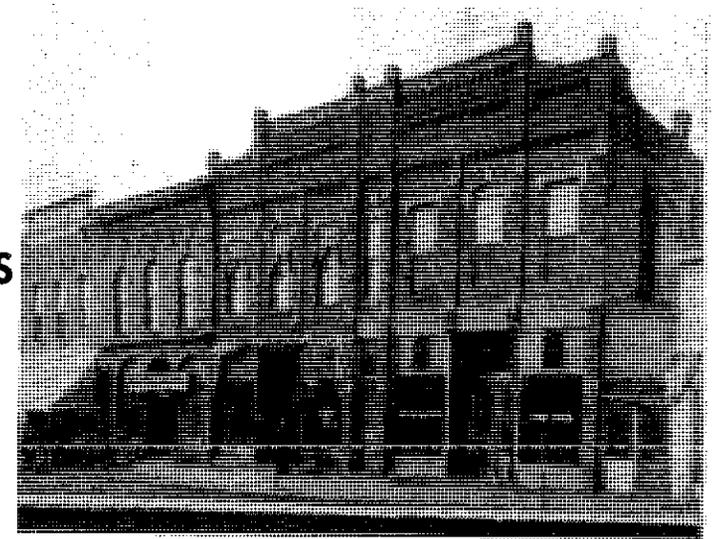
MASON BARGAIN SHOES
158 West Maple Street
1887

ARCHITECTURAL DESCRIPTION: The Mason Shoe Store building has been altered perhaps more than any other building found in the historic district. The building consists of a two story on the west and a one story infill building on the east. The street level portion of the building has been covered with a cultured lava rock, which is totally out of character with the district architecture. Display windows run the width of the two story portion of the building and consist of aluminum frames with large panes of glass. A single wooden door is located on the west side of the building which apparently leads to a stairway to the second floor.

A recessed entrance is found on the east corner of the two story portion of the building. The recess is treated with vertical reversed board and batten wooden siding. The easterly portion of the building, the one story infill building, is covered with the cultured stone and has a recessed six panel wood door. The wood door is colonial in character. Three vertical slot type windows surrounded with cedar boards offer a relief in the cultured stone front.

A panel of diagonal cedar boards runs above the storefront windows the full width of both buildings. The second story portion of the westerly portion of the building is sided with wood reversed board and batten siding. This siding covers any detail that may remain of the original building. Above the wooden siding is a shingled mansard roof which apparently returns over the original parapet wall.

The business sign consists of a shoe that is symbolic of a clown's shoe with a rather long foot with a large bulging toe section. Upon the shoe is painted the name of the store. The "modernization" of this storefront has totally obscured the original architecture. It is uncertain if any of that original character still exists at the second floor. However, it is certain that none of the original character remains at the street level.

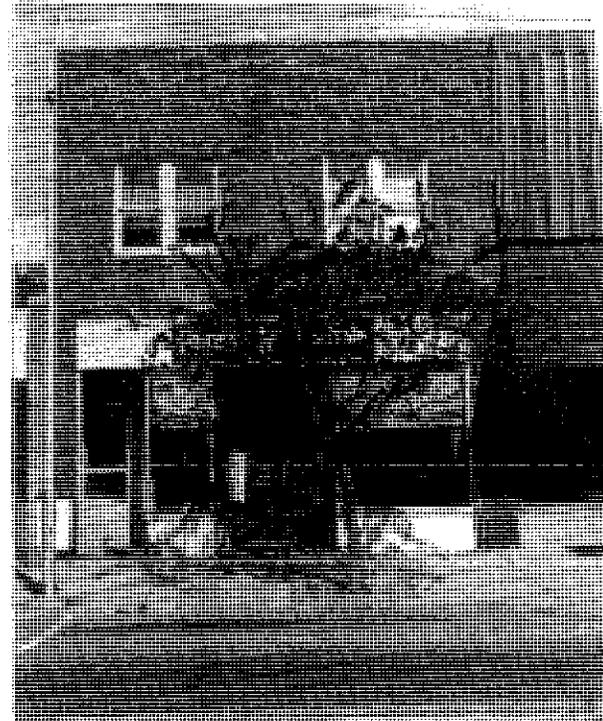
PANSY'S NEEDLEHOLE
124 West Maple Street
1929

ARCHITECTURAL DESCRIPTION: Pansy's Needlehole is a two story brick building which appears to be a 1930's vintage infill building.

A recessed doorway leading to the stairway to the second floor is found on the west side of the building.

The brick below the display windows has been painted white, however, the remaining portion of the building is a brown-orange brick which is very typical in the 1930's and 40's. A simple sign board is located just above the display windows and running the full width of the store.

The second story portion of the building is a flat brick wall with two sets of side-by-side double hung windows with a center mullion. These double hung windows are considerably smaller in height than that found on the older buildings in the district. The brick wall is capped with a poured in place concrete coping.

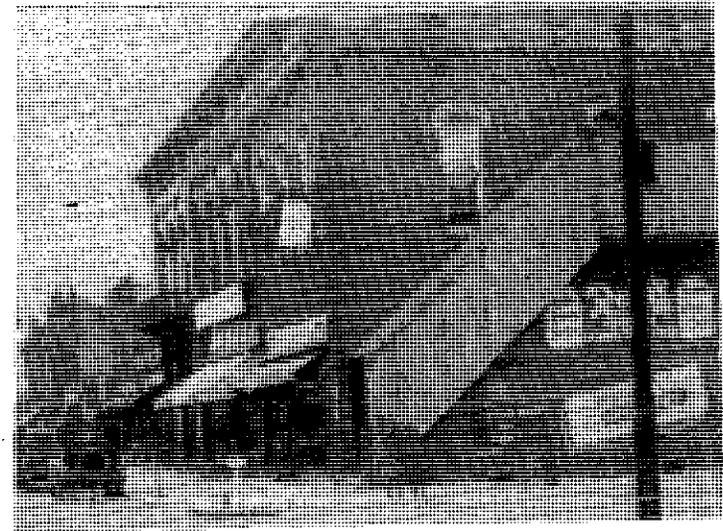
DANCER'S FASHIONS
198 West Maple Street
1886 - 1890

ARCHITECTURAL DESCRIPTION: Dancer's Fashions consists of two buildings. The westerly portion of the building is a single story building which appears to be an infill. This one story portion was originally a portion of the building that is described as Pansy's Needlehole. The remaining portion of the building is a three bay, two story high building.

The street level portion of the facade has been greatly altered from its original character. The original storefronts were removed and a new storefront consisting of a brick kneewall with large lites of glass set in bronze framing making the display windows. The brick on the street level facades is of a different character than that found on the original building.

A mansard type canopy with cedar shake shingles has been installed between the aluminum Shadowform siding and the head of the display windows. This mansard roof takes on a Bavarian character through the addition of gabled dormers located over each of the entrances.

A surface applied script sign of contemporary design and covering nearly 50% of the two story building is applied to the aluminum Shadowform facing.
